# STRUCTURE NO. 05810

LAPHAM ROAD

ROUTE 15

*Indepth Inspection*

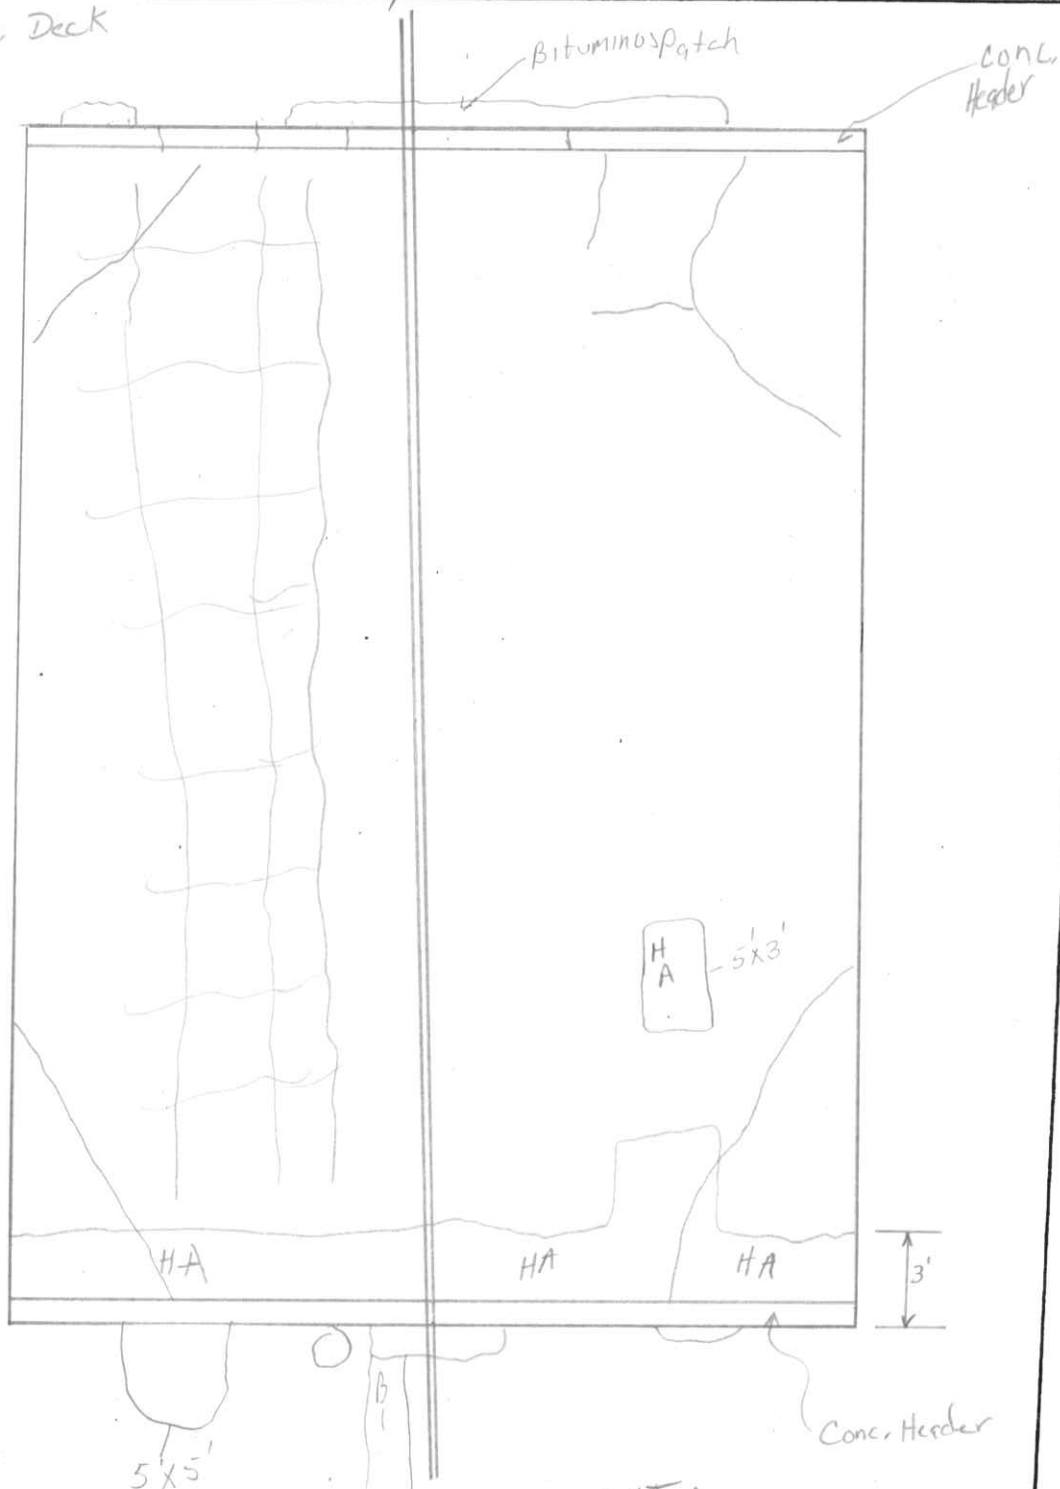
Topside Bare Conc. Deck

OVERLAY:	6	Latex modified concrete exhibits: Longitudinal and transverse cracking throughout up to 1/16" wide.  Areas of light mapcracking.  A 3' x 3' and a 4' x 1' hollow area over the south abutment.  A 3' x 2" x 1" deep spall over the north abutment.  Bands of diagonal cracking at all four corners up to 10' long. Deck has a deep hollow sound because there is a gap between deck units and concrete deck. Deck was chain dragged.
DECK-STR. CONDITION:	6	Integral Deck: Per CT Bridge Inspection Manual rating based only on the condition of the riding surface.
CURBS:	7	Sloped granite blocks with minor scrape marks.
MEDIAN:	N	-
SIDEWALKS:	N	-
PARAPET:	7	Cast in place and precast facade panels attached below parapet. (see GIRDERS item for description of condition). The parapets have random vertical hairline cracks, some with efflo.
RAILING:	N	-
PAINT:	N	-

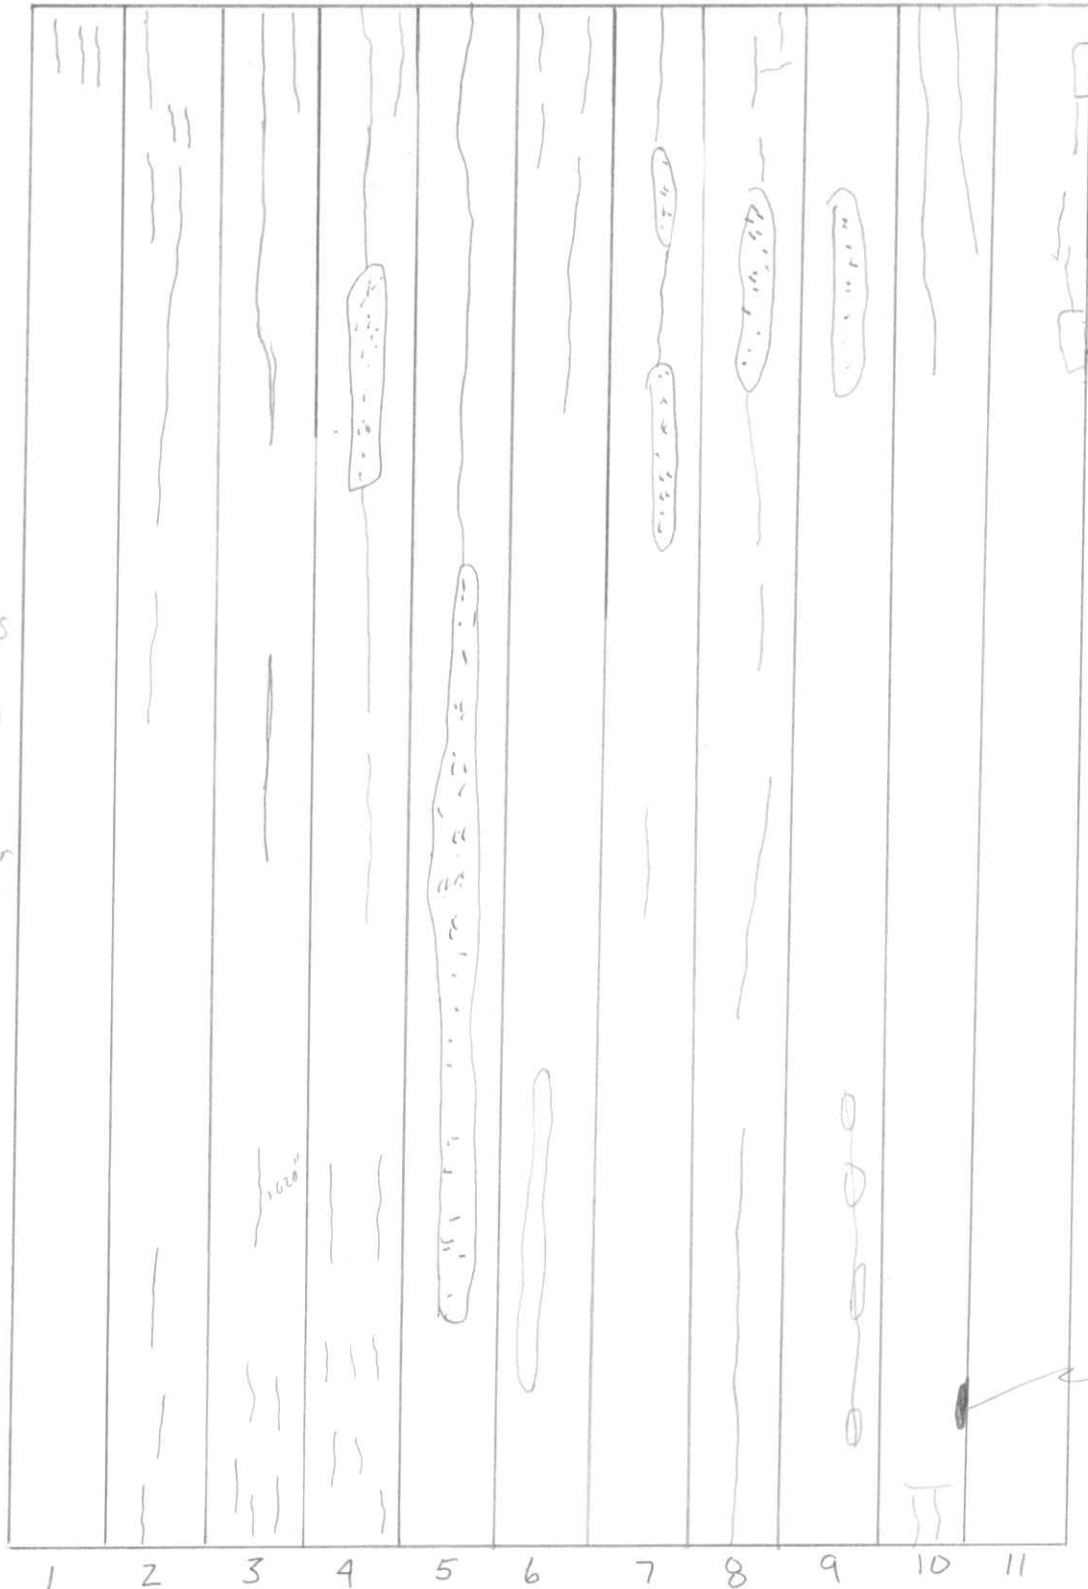
Abutment #2 N.T.S

Efflo Frosting

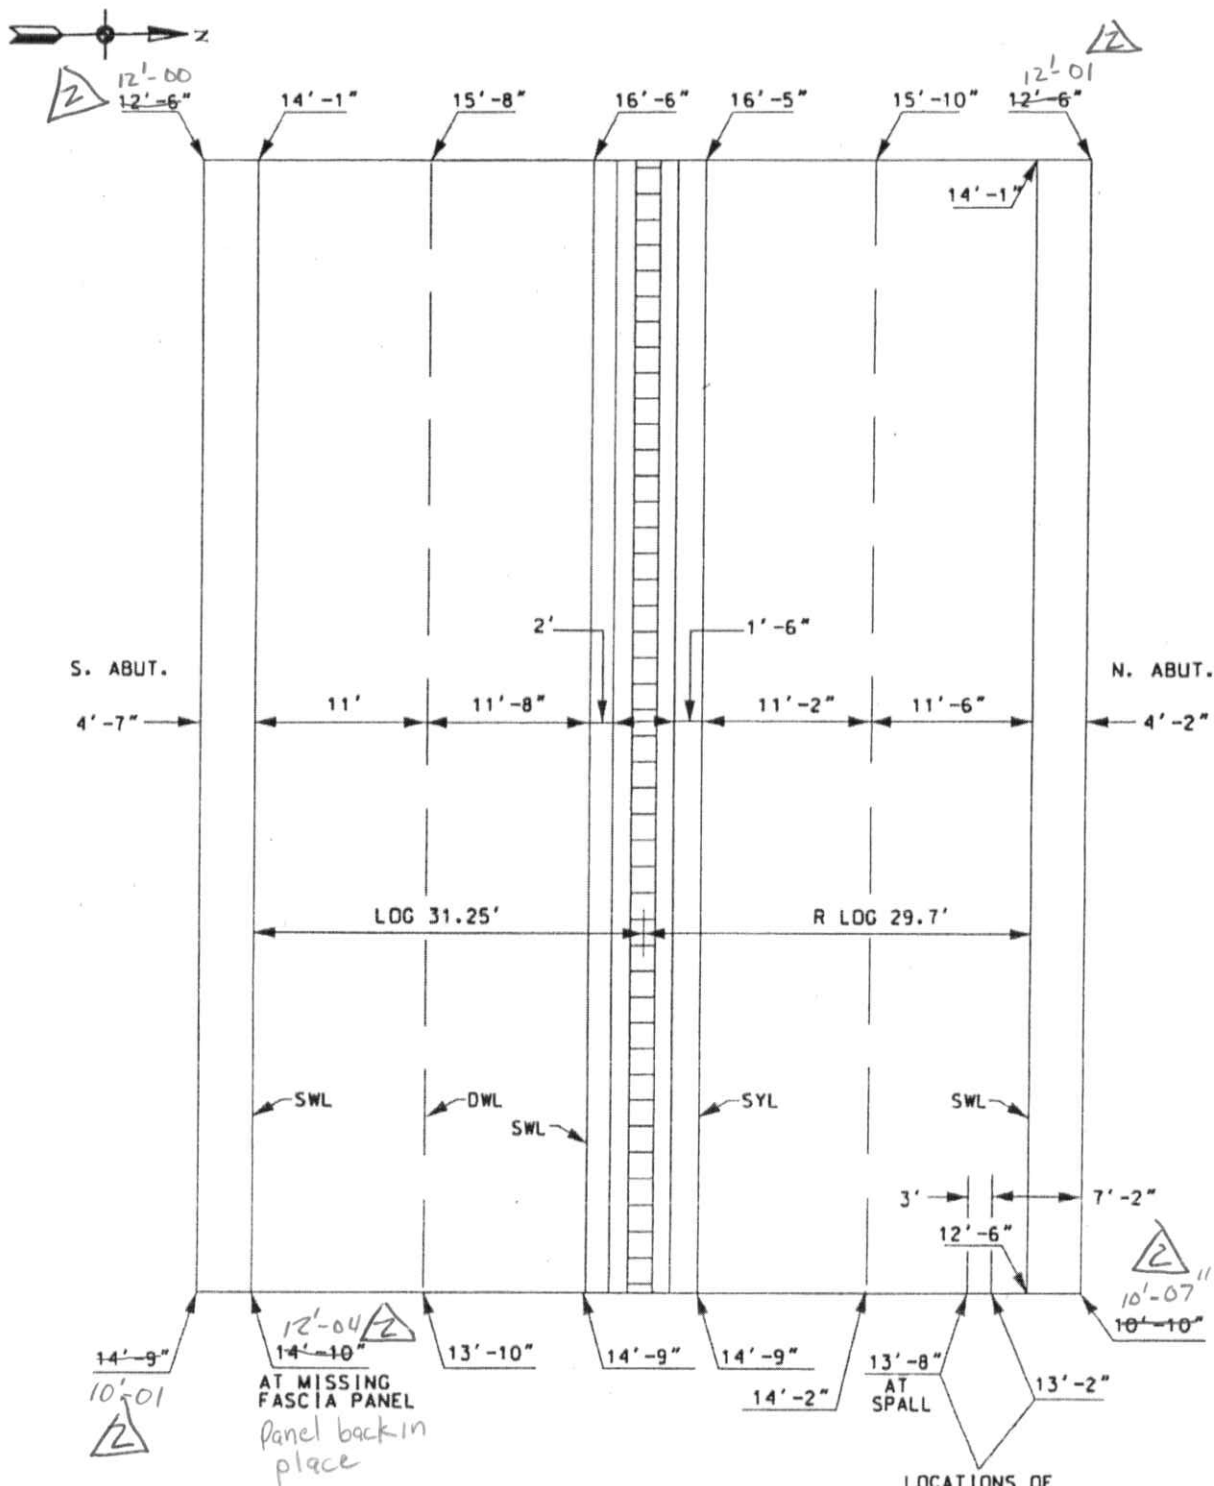
CLEARANCE DIAGRAM  
(N.T.S.)

MIN. VERT. UNDERCLEARANCE:	Last Inspection:	At edge of travelway. (10-10" at edge of roadway).
	12' 6" Current: -' -"	
POSTED CLR. UNDER BRIDGE:	Last Inspection:	See below.
	12' 2" Current: -' -"	
POSTED CLR. ON BRIDGE:	Last Inspection:	None.
	0' 0" Current: -' -"

<b>ADVANCED WARNING (YES/NO):</b>	No	12'-1" posted southbound approximately 100' from bridge with no other advance warning. 12'-3" posted northbound approximately 100' from bridge with advanced warning on Route 124 entrance ramp.
<b>SPEED LIMIT (IF ANY):</b>	Last Inspection: -	
	Current: -	
<b>CHARACTER OF TRAFFIC:</b>		Light and mixed.

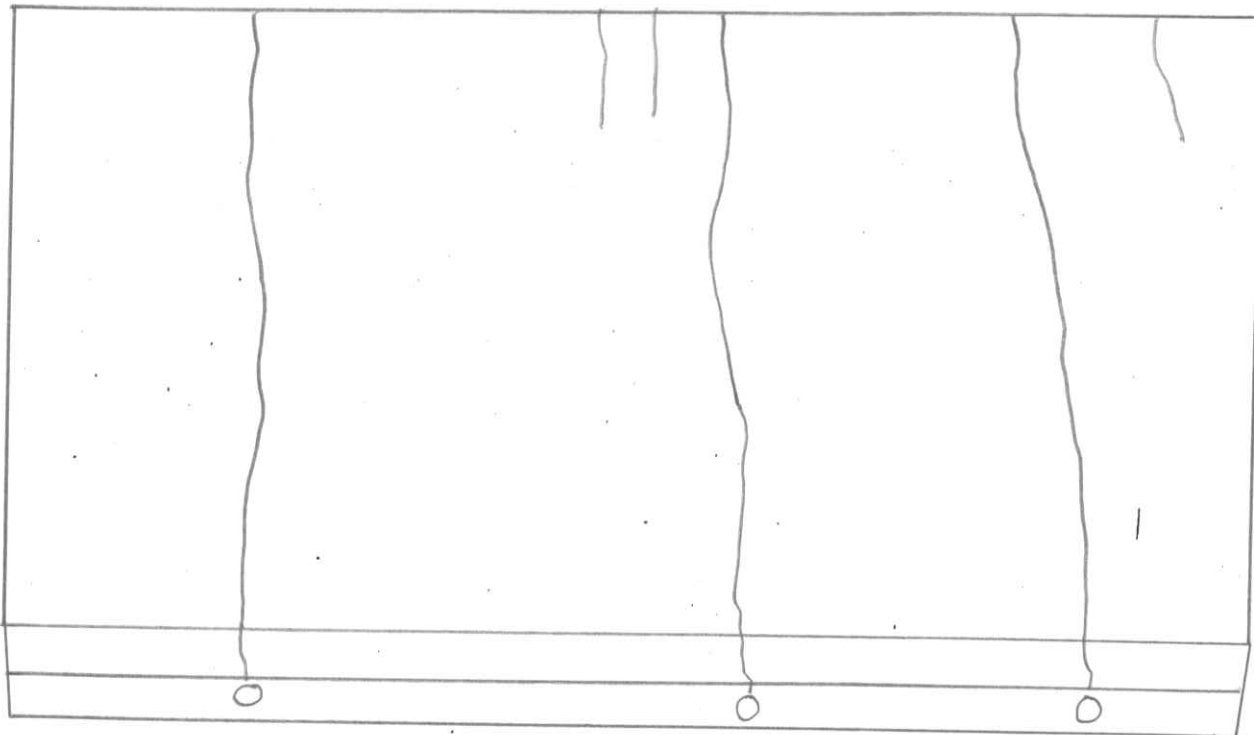
Abutment #1 N.T.S

ABUTMENTS-STEM:	7	The southwest abutment seat has a full width x 6" x 3" deep spall at the top on the fascia side and there is evidence of leakage.  At each abutment there are 4 full height and a few partial height cracks up to 60" long. All of these cracks are hairline to 1/16" in width. The granite curb at the bottom of the concrete crash walls have minor scrapes.
ABUTMENTS-BACKWALL:	N	Not visible.
ABUTMENTS-FOOTINGS:	N	Not visible.
ABUTMENTS-SETTLEMENT:	N	-
ABUTMENTS-WINGWALLS:	5	The wingwalls have daigonal and transverse cracks up to 7' x 1/16" wide with efflorescence and the following deterioration:  Southwest and southeast wingwalls: There are a few spalls up to 2' x 6" x 3" deep. Also, there are several locations of heavy scale up to 2' x 4' x 1" deep with heavy efflorescence. The southwest exhibits an area of map cracking with hollow concrete on the pylon and wing totalling 140 sf.  Northwest and northeast wingwalls: Each wingwall has one large spall with exposed rusted rebar, 2' x 2' x 6" deep and 2' x 1' 6" deep respectively. Also, the northwest wingwall has a 2' x 2' hollow area with large cracks and edge spalls around.

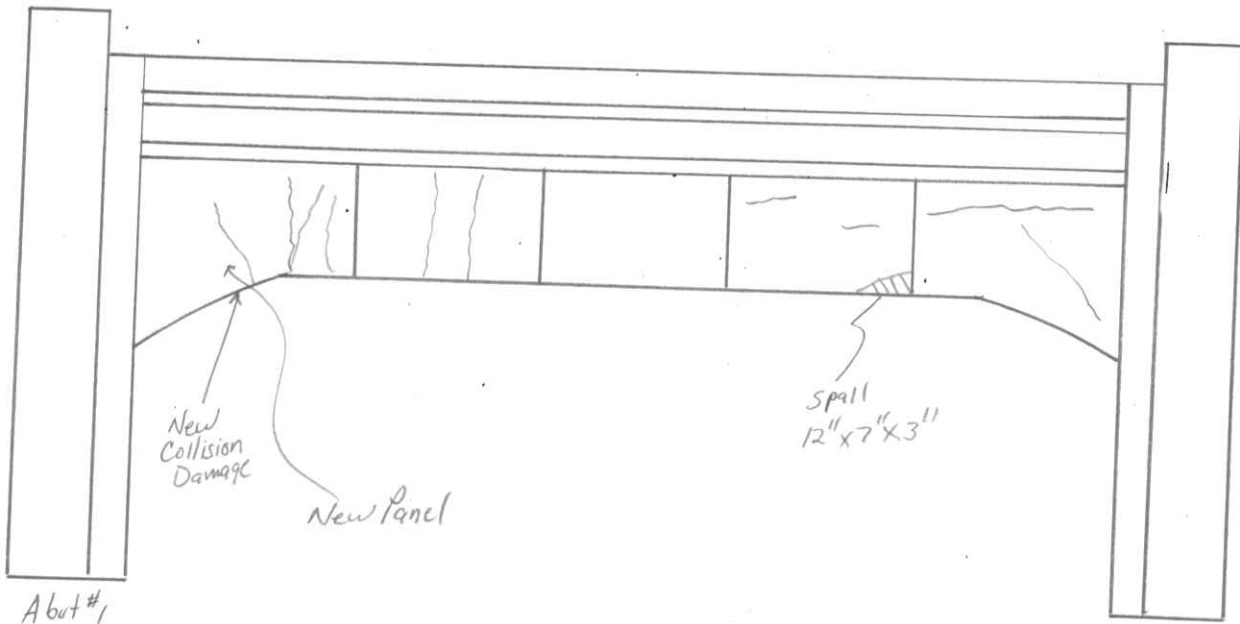
East Elevation N.T.S.

<b>BEARING DEVICES:</b>	7	<p>The premolded joint material at the south abutment is squeezing out under random units.</p> <p>The elastomeric bearings at the north abutment appear to be in good condition based on limited view.</p>
<b>STRINGERS:</b>	N	-
<b>GIRDERS:</b>	6	<p>The underside of the prestressed deck units exhibit: Intermittent longitudinal hairline cracks at random locations on all units up to 30' long x up to 0.030" open.</p> <p>Typically the longitudinal cracking ranges from 2' to 8' long x 0.020" open. There are isolated honeycomb areas with and without mortar patches. There is moderate efflorescence between units 10 and 11 near the south abutment.</p> <p>The precast façade panels have random hairline cracks. Panel 1 and a portion of panel 2 on the east side over the northbound right lane have been replaced with new panels. This new section has minor collision damage.</p> <p>However there is a portion of panel 2 that has two 1/8" wide cracks on the interior face over the left lane. The concrete sounded solid but this condition should be monitored during future inspections. There are isolated areas of mapcracking, shallow spalls and vertical hairline cracks on the other panels.</p>

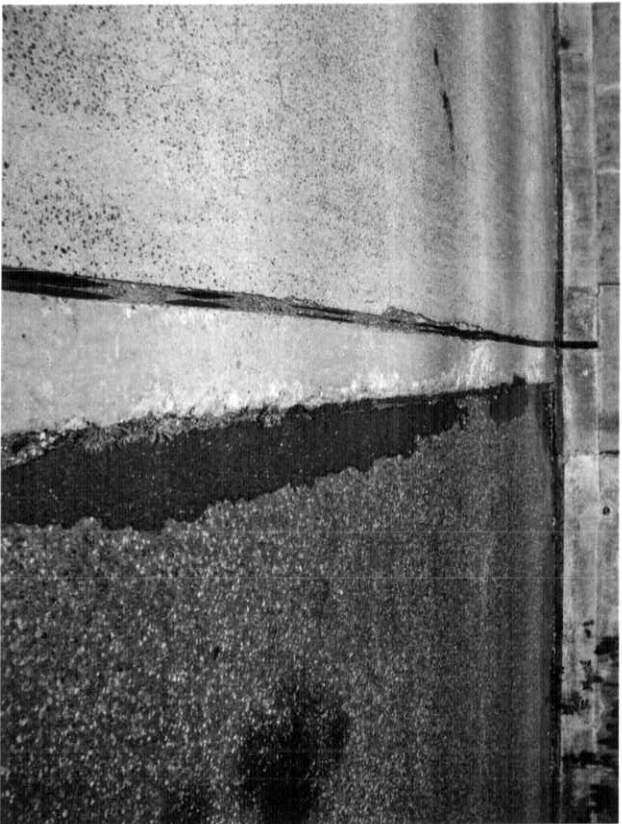
**Photo #3 :**

<b>FENCE:</b>	N	-
<b>DRAINS:</b>	N	-
<b>LIGHTING STANDARD:</b>	N	-
<b>UTILITIES TYPE/SIZE:</b>	8	There are 4-1/2 inch telephone conduits attached to underside of box girder 1.
<b>CONSTR JOINTS:</b>	N	-
<b>EXPANSION JOINTS:</b>	6	<p>North Abutment: The compression joint seal is filled with sand. The concrete header has transverse hairline cracks, impact scrapes, and edge spalls up to 20 linear feet.</p> <p>South Abutment: There is no formal joint at the south abutment. There is a gap up to 2" filled with sand between the approach pavement and overlay. There is 20 linear feet of bituminous spalling adjacent to the open joint.</p>

**Joint over abutment #2**

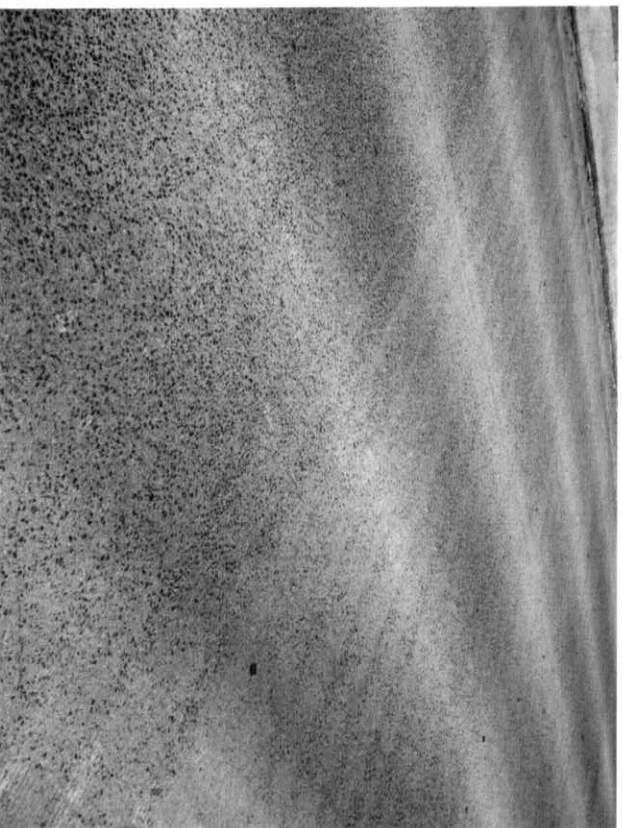
**Photo # 4:**

**General view of wearing surface**

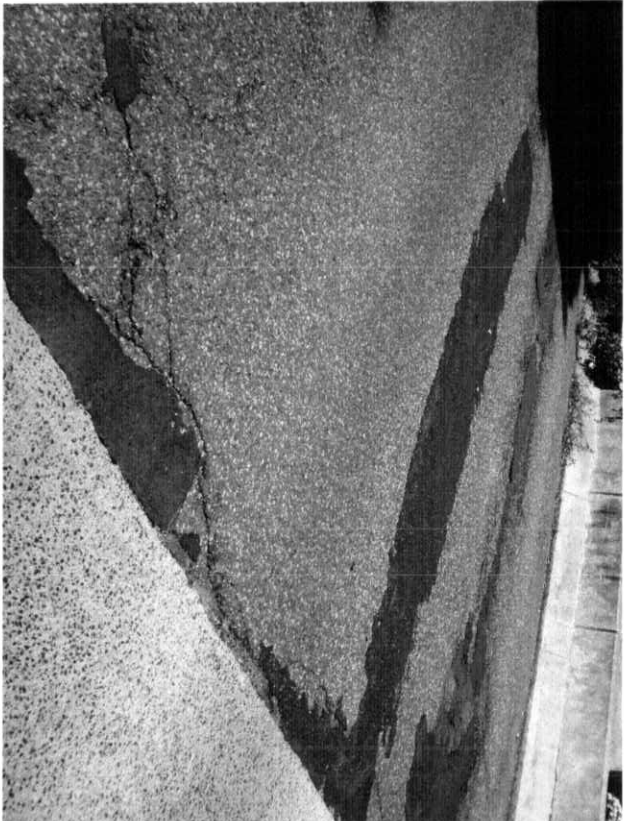
**Photo #5:**

APPROACH SLAB:	N	-
RELIEF JOINTS:	N	-
APPROACH GUIDE RAIL:	7	Metal beam rail at all four corners. There is minor impact damage at the southwest corner.
APPROACH PAVEMENT:	4	South approach: The bituminous concrete has heavy ravelling with potholes up to 1' diameter x 1" deep in the wheel paths. There is several transverse and longitudinal cracks open up to 1" wide throughout and uneven bituminous patches. Bituminous patches on both approaches. (see sketches)
APPROACH EMBANKMENT:	8	-

**Bit. patches approach pavement south**

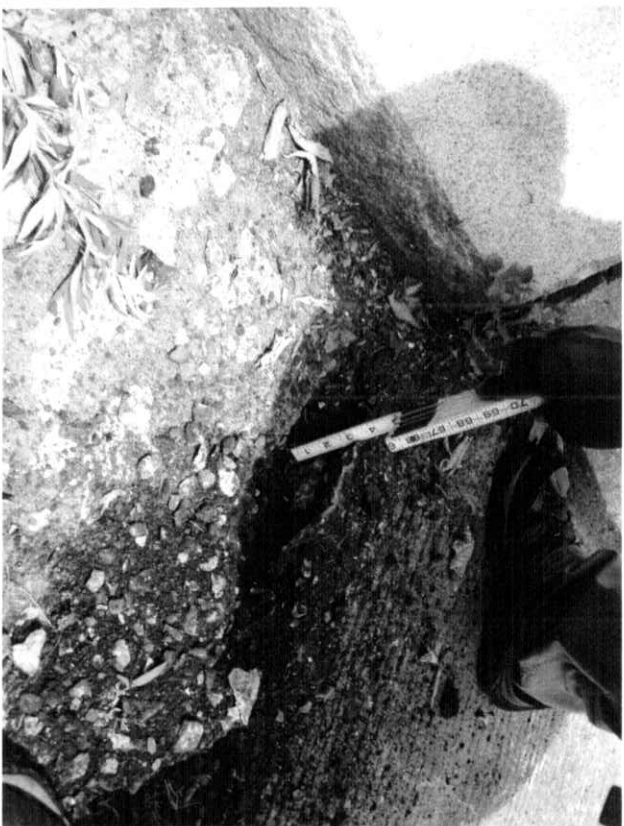
**Photo #6:**

**2" wearing surface taken at southwest edge**

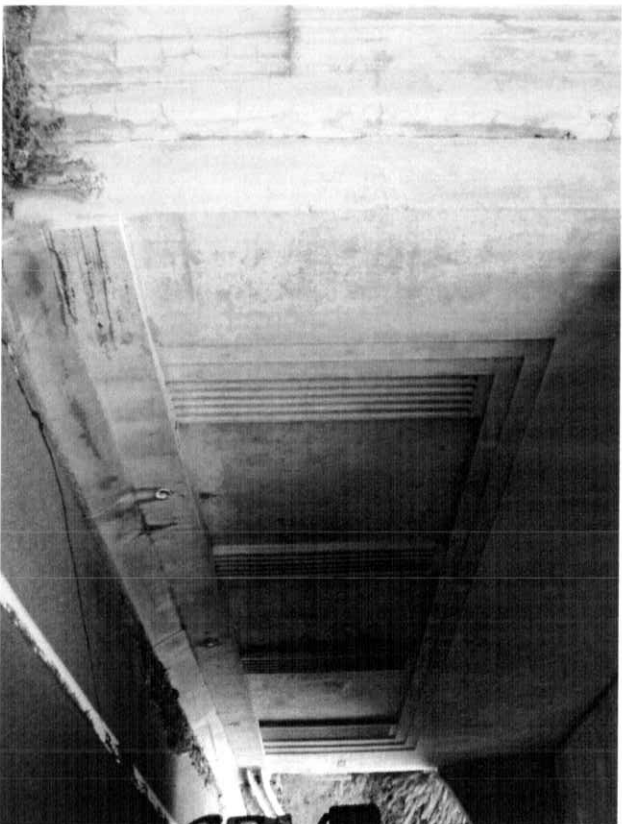
**Photo #9**

**General condition of abutment #1**

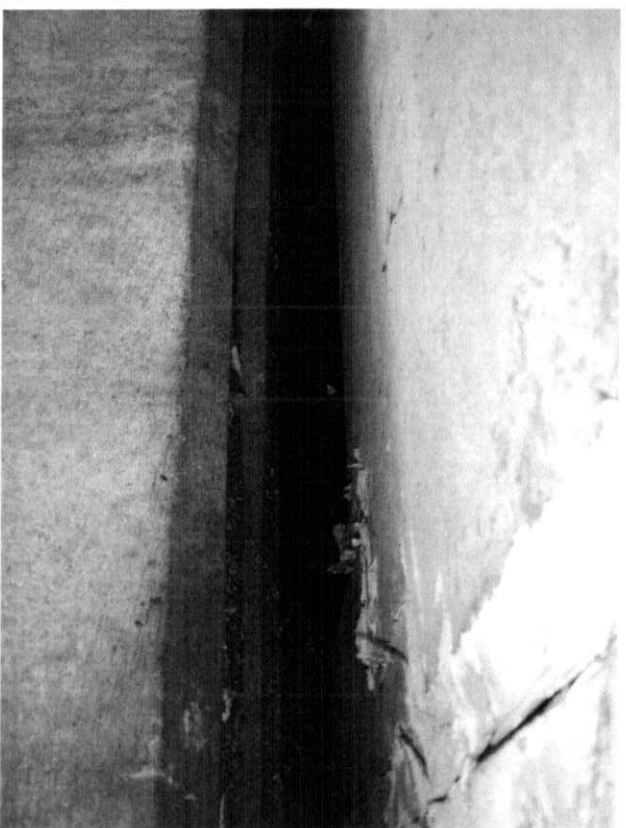
**Photo # 10**

**Typical elastomeric bearing pad over abutment #1**

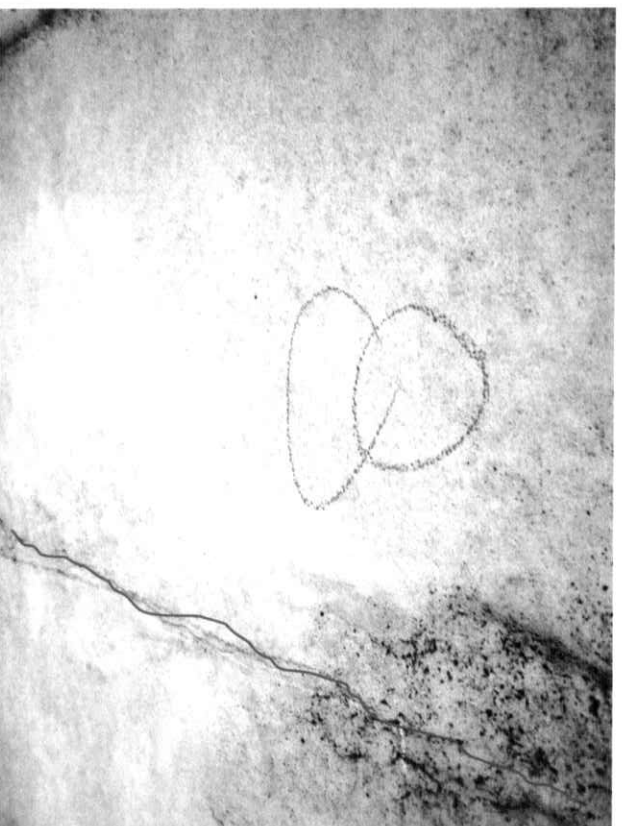
**Photo # 12**

**Typical crack bottom of unit #8**

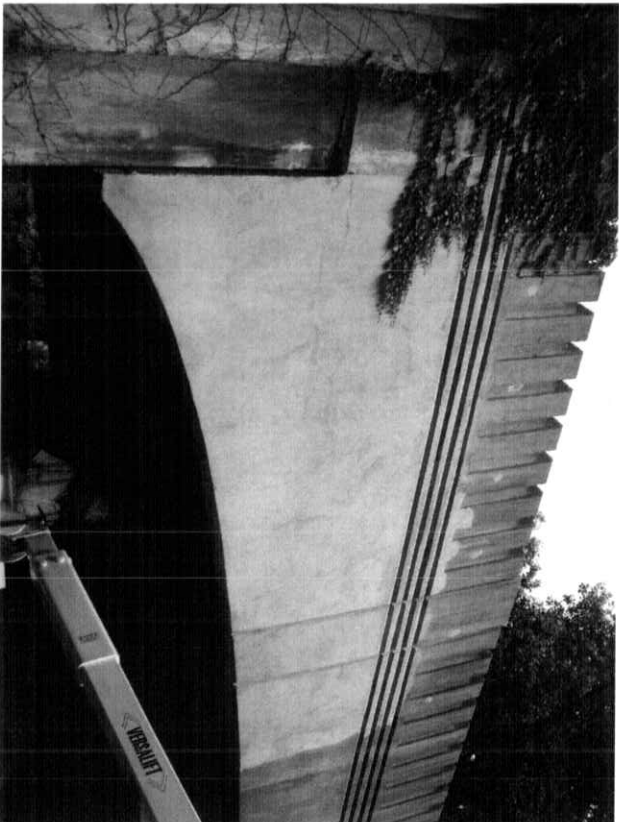
**Photo #13**

<b>FLOOR BEAMS:</b>	N	-
<b>TRUSSES-GENERAL:</b>	N	-
<b>TRUSSES-PORTALS:</b>	N	-
<b>TRUSSES-BRACING:</b>	N	-
<b>PAINT:</b>	N	-
<b>RUST:</b>	N	-
<b>MACHINERY MOV SPAN:</b>	N	-
<b>RIVETS &amp; BOLTS:</b>	6	<p>There are angles that are bolted to the underside of the fascia units and to the interior of the façade panels.</p> <p>One out of the seven bolts is not fully engaged, but tight (washer is loose) at the following locations: West fascia , at panel 1 over the right lane northbound. West fascia, at panel 5 over the right lane southbound. There is up to a 5/8" gap between the panel and angle at these locations.</p>
<b>WELDS - CRACKS:</b>	N	-
<b>TIMBER DECAY:</b>	N	-
<b>CONCRETE CRACKING:</b>	5	See GIRDER comment and COLLISION DAMAGE.
<b>COLLISION DAMAGE:</b>	6	100% collision damage panel 1 and portion of panel 2 removed by CDOT maintenance.

**New panel at southeast with collision damage**

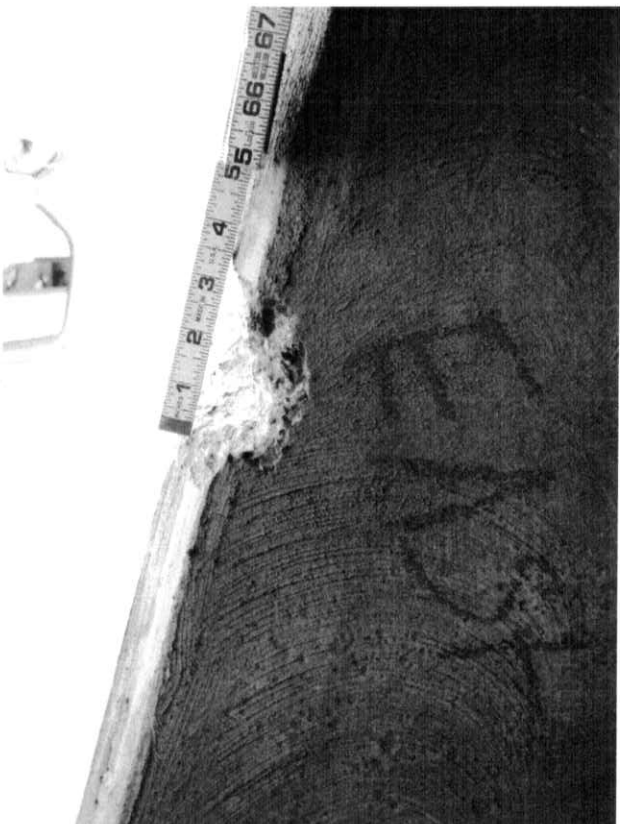
**Photo # 14**

**Small spall with vertical cracks from collision damage bottom of panel at southeast**

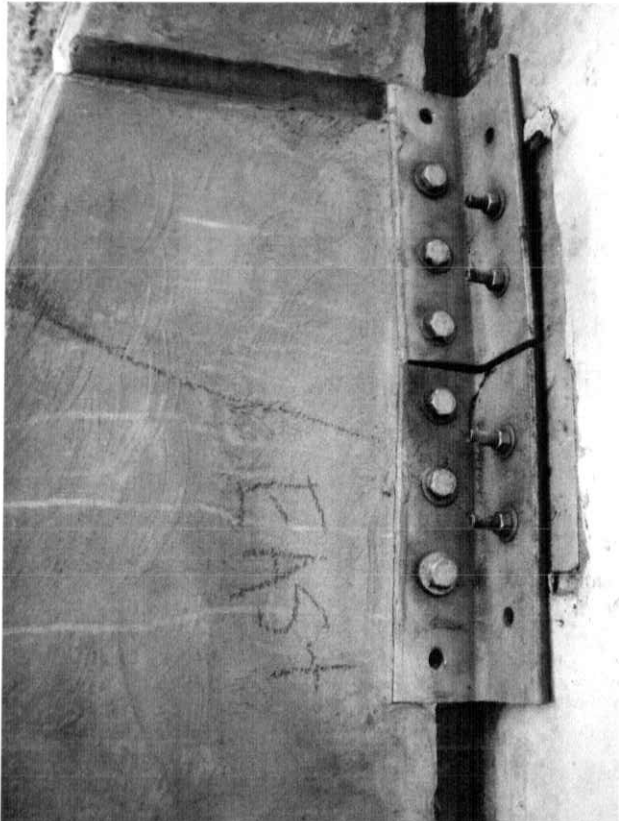
Photo #15

Vertical cracks in east panel from collision damage

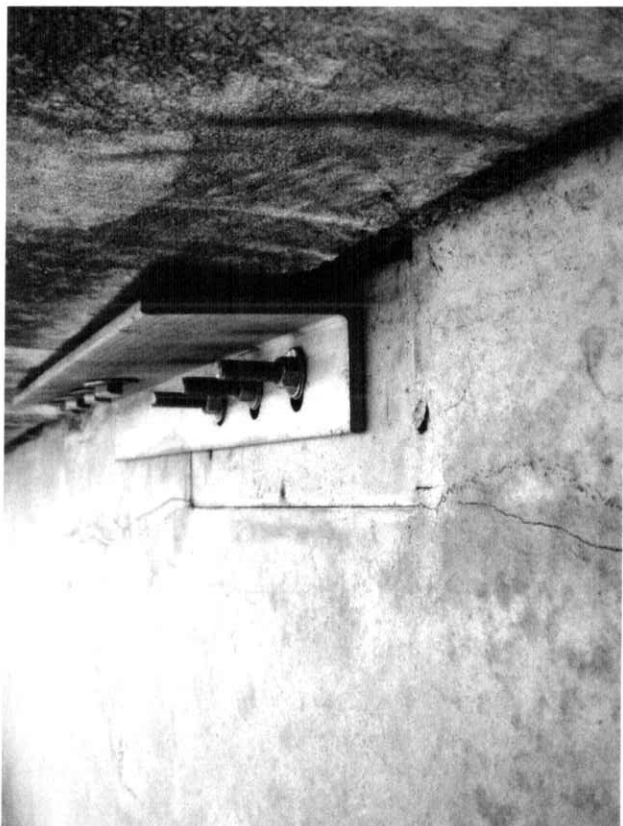
Photo # 16

Cracks adjacent to panel random hanger bracket
